HISTORIC AMERICAN BUILDINGS SURVEY

INVENTORY

Taylor House (scott House)

Wo-75

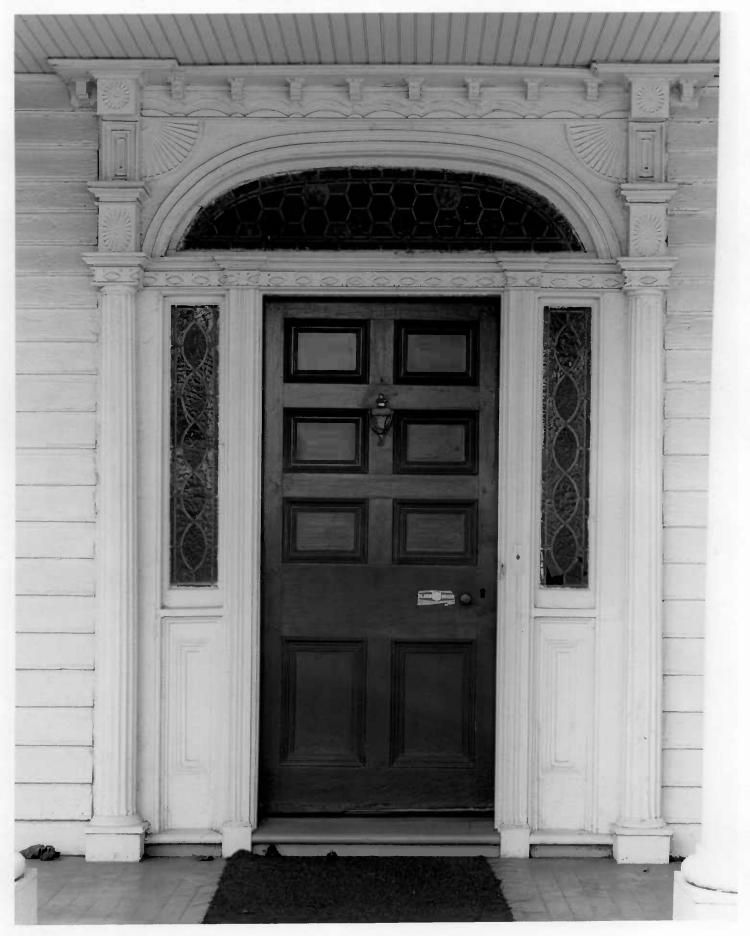
NO-75

This house is typical of the Berlin Federal houses in that its facade is the gable. It is a three-bay-wide by three-bay-deep frame structure covered with beaded clapboard, built on a brick foundation. It differs from the other houses in its entrance which has an elliptical transom above the door with sidelights and fluted pilasters. The upper part of the pilasters have elliptical sumbursts, a panel and a rosette and finally a cornice with modillion and wave motif. Between the door and transom is a series of elliptical carvings and in the corners left by the elliptical transom are irregular sumbursts. The entrance is covered by a flat roof doric portico which has four columns on the outside and no visible means of support against the house.

ENTRANCE, EAST ELEVATION
